# CENTRAL MARIN SANITATION AGENCY

## Big Milestone in Sight for Exporting Excess Power

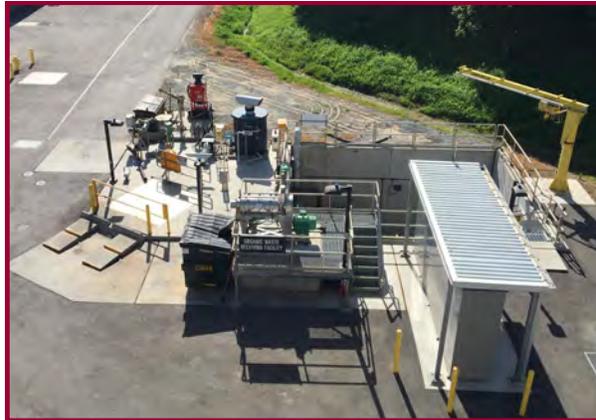
*CMSA's Organic Waste Receiving Facility, which is planned to be expanded.*

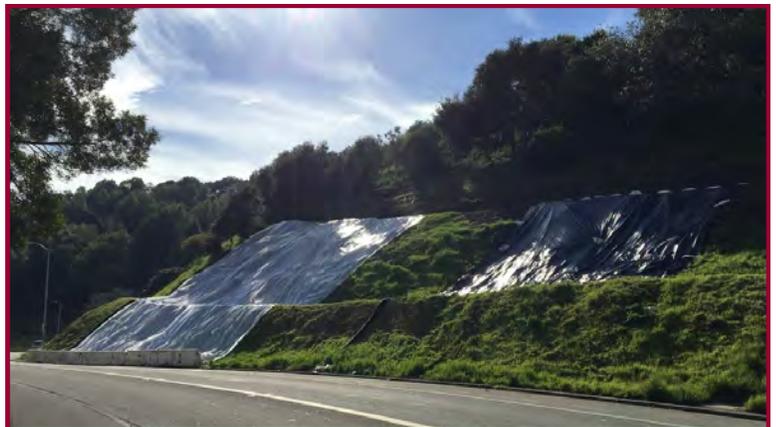
After the February 2017 storms, five landslides occurred on the Andersen Drive hillside. CMSA selected Miller Pacific to evaluate repairs for the slides with the designated work being subject to reimbursement by the Federal Emergency Management Agency (FEMA). The selected alternative involves constructing soldier pile retaining walls to stabilize the upper portion of each slide area and reducing the slopes to conform to adjacent grades.

*Landslide sites on Andersen Drive with tarps for temporary protection.*

FEMA and the California Office of Emergency Services (Cal OES) authorized proceeding with the retaining wall design and to formally bid the construction project. Staff will seek Board approval to publicly bid the project in the next few months after the completion of the environmental review. It is expected that the entire construction cost and portions of CMSA staff time spent on project management will be eligible for reimbursement by FEMA.

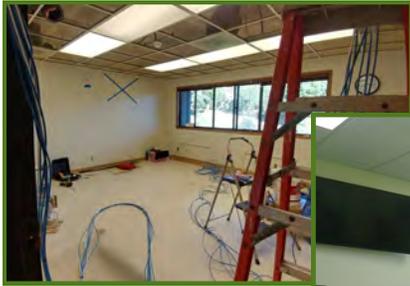
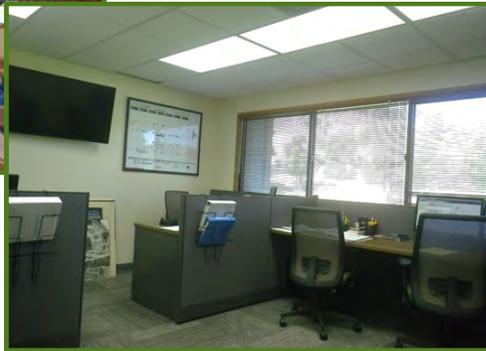
*Old engineering office being re-wired (above), and newly remodeled control room (right).*

After the engineering staff relocated to the remodeled maintenance building last spring, their old office was repurposed and outfitted as the Agency’s main control room.

Control rooms serve as a central space where both on- and off-site facilities can be monitored and controlled, and this move required extensive wiring upgrades. Eleven staff members on three shifts share this space, which is equipped with multiple electronic displays, communications and network software, and enhanced desk space for individual project work. This space replaces the original control room, a busy open corridor that also doubled as the facility’s main server room.

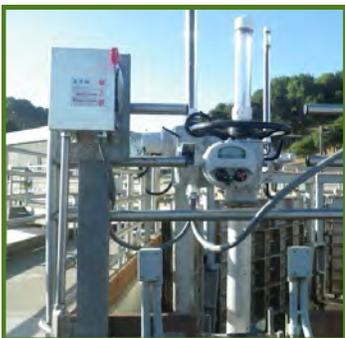
*New automated gate controls.*

and their controls automated. Technicians recently replaced the manual isolation gate that separates secondary effluent from the Agency’s effluent storage pond. This new gate is fully-integrated into the Agency’s process control system, and has the capability of opening

when blending occurs and closing when the pond is full. The gate is crucial during winter storm events, when blended wastewater is sent to the pond for temporary storage; a provision in CMSA’s NPDES permit. Gone are the days that two staff members were required to open and monitor this important gate.

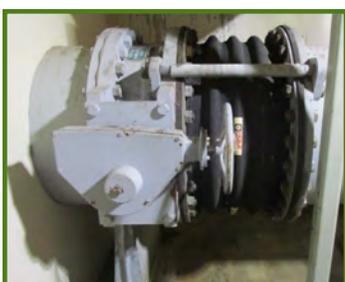
Expansion joints are separation devices designed to relieve stress on piping that is typically caused by building movement such as settling or seismic activity. Over time, these joints weaken and crack and require replacement. A multi-year replacement schedule was developed last year

and six 30” expansion joints have been procured for process piping. The first, in the biotower basement, was recently replaced by Agency technicians, with plans to replace the rest over the next several months.

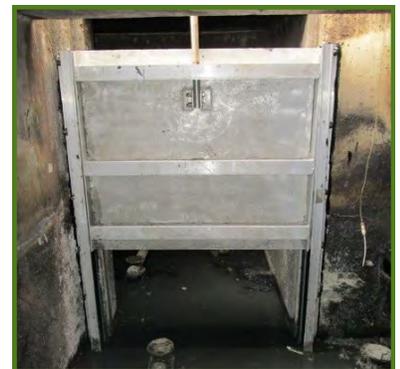
There are 12 channel isolation gates on the primary clarifier influent deck. These gates provide process control options: flow distribution to, or the isolation of, a primary clarifier. Over the past four years, staff have been replacing these gates, and replacement of

*New isolation gate in place.*

the final four gates required staff to divert flow in the middle of the night to perform a confined space entry (CSE) to install a temporary “coffer” dam. This allowed for dry work on one side of the dam while normal treatment was carried out on the other side. This process was reversed once one side was completed. On one final mid-night flow diversion, a CSE was performed to remove the temporary dam. Staff also used the opportunity to rehabilitate the gate actuators and base plates for each new gate.

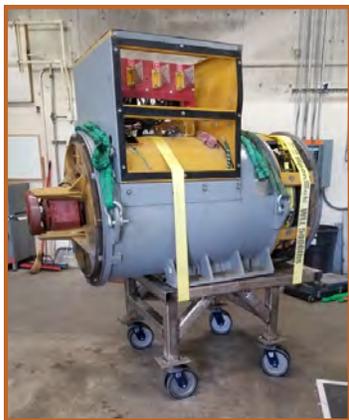
The Agency's cogenerator had to be removed from service in early August after the generator's stator winding failed. This system is vital, as it typically produces more than 95% of the total electricity and 100% of the heat for the Agency's processes, buildings, and equipment. Repairs required

*Cogenerator offline for repairs.*

uncoupling the generator from the engine by CMSA staff, and transporting it to a local service facility. The generator was returned two weeks later after extensive testing, troubleshooting, and repairs. The cogeneration system was started on August 24 and immediately began producing green power for the facility.

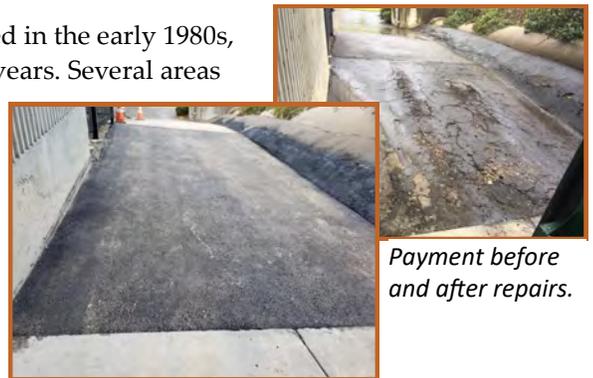
The roadways at the facility were constructed in the early 1980s, and have been repaired as needed over the years. Several areas were showing significant cracking, settling, and potholing which needed attention. CMSA requested competitive bids and selected Alaniz Construction to repair approximately 4,200 square-feet of worn pavement surfaces. The work included digging out failed asphalt areas, grinding off edges of the existing pavement, and laying new asphalt. Alaniz completed the work by the end of September, within budget. Another pavement rehabilitation project is planned to be put out to bid by the end of this year.

*Payment before and after repairs.*

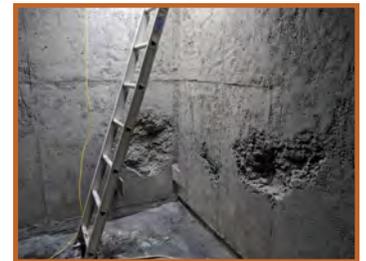
CMSA hired Top Line Engineers to repair the epoxy coatings in the sodium bisulfite chemical storage room and in the sodium bisulfite and sodium hypochlorite drain vaults. The existing epoxy coating had cracks and delamination in several locations and had completely

*New coating in bisulfite storage room, spalled concrete in hypochlorite vault.*

failed in other areas. While blasting the hypochlorite vault walls to remove the failed coating, Top Line discovered areas of spalled concrete and corroded rebar. They treated the rebar for corrosion protection and applied repair mortar to the failed concrete. Coating for all three areas was completed in September.
